APPENDIX 8. INVESTIGATIONS – INTERIM AUDIT ADVICE

SITE CONTAMINATION AUDIT SYSTEM INTERIM AUDIT ADVICE FORM

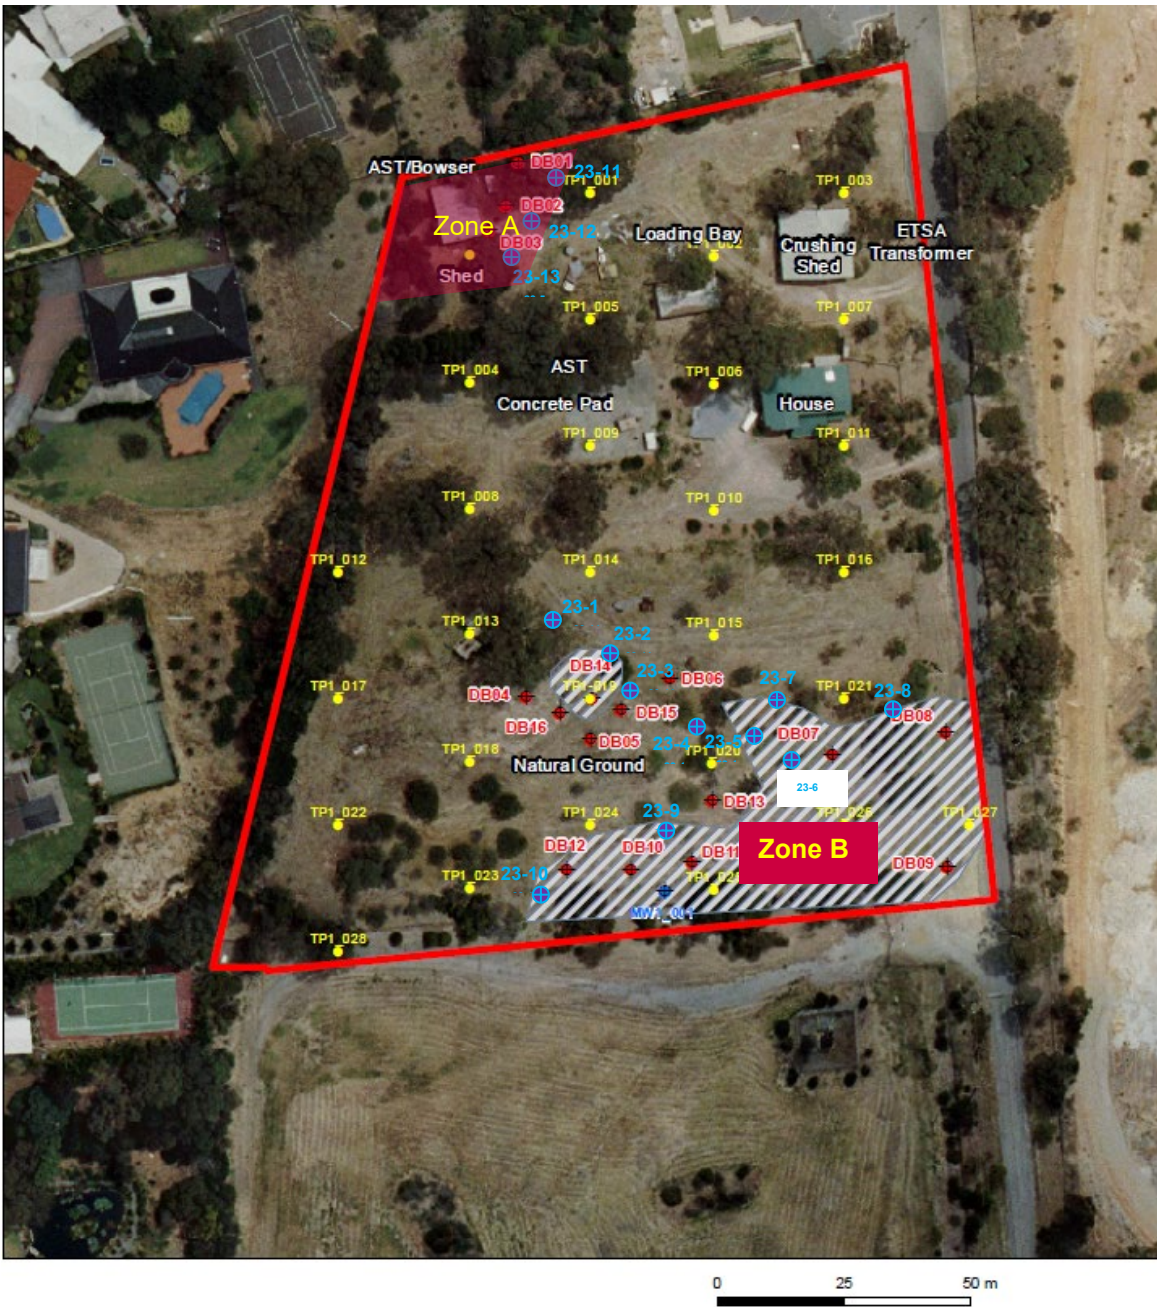
Figure 4-3 Delineation bores 2023

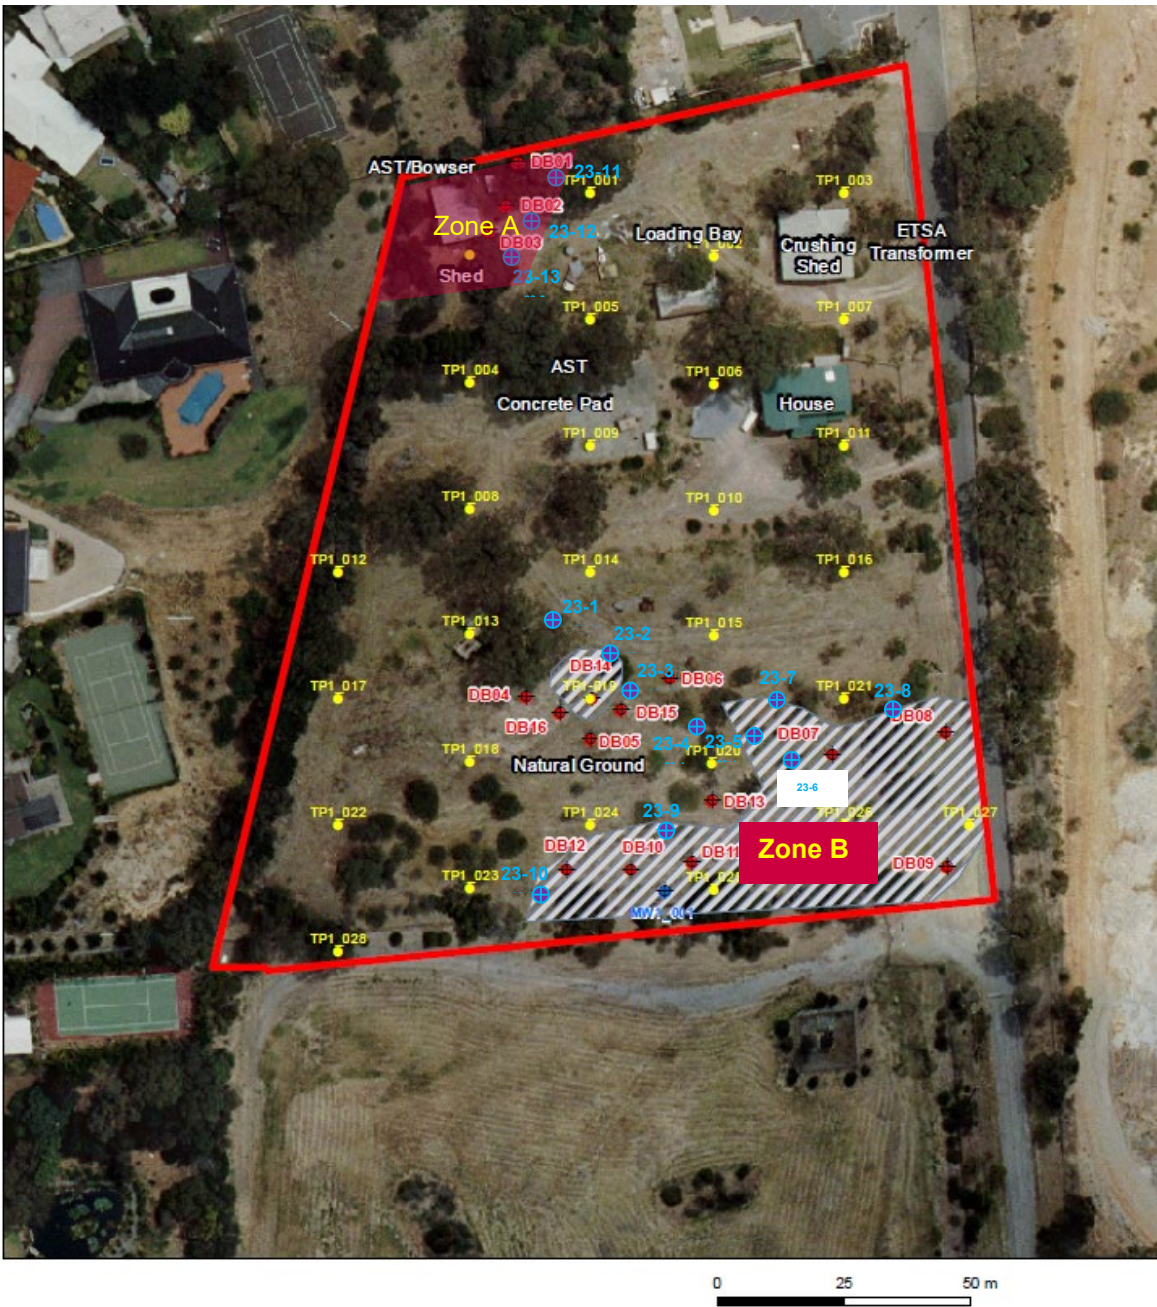
Figure 4-3 Delineation bores 2023

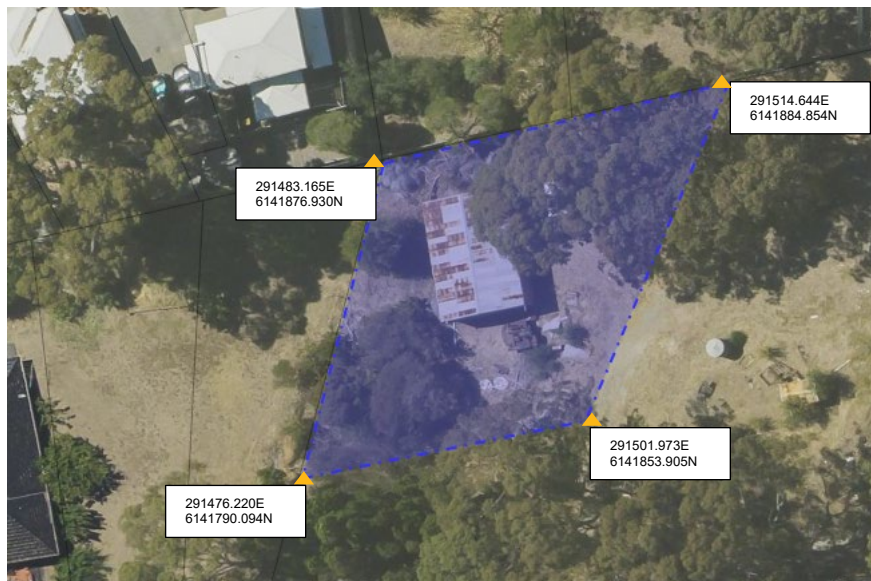
Figure 4-4 Coordinates of Zone A

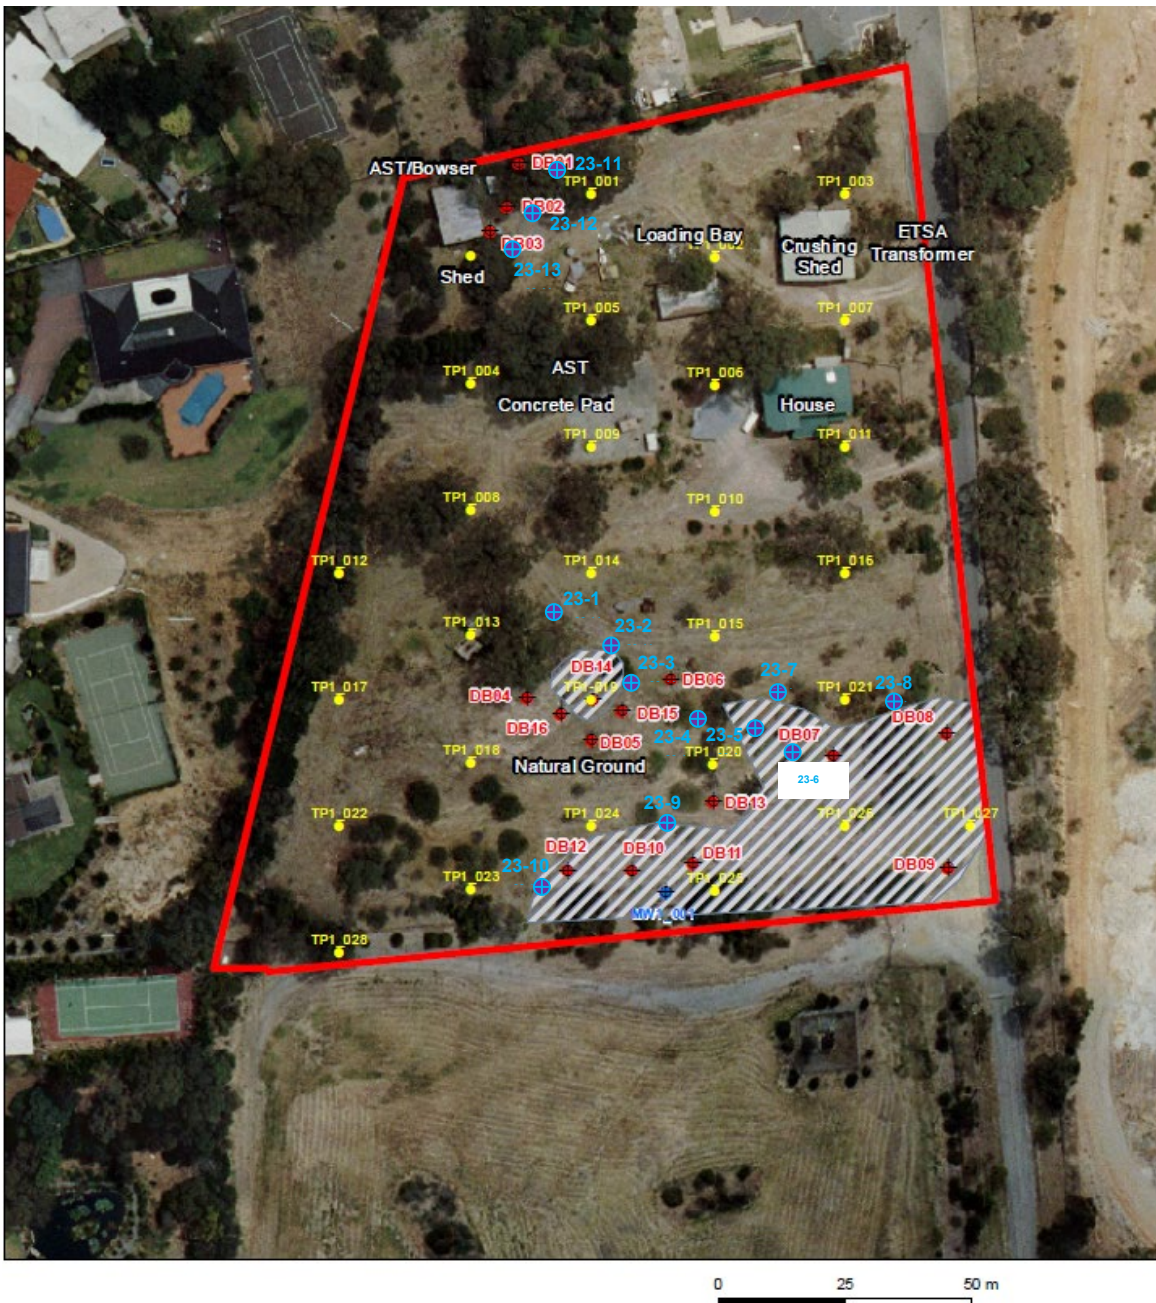
Figure 4-3 Delineation bores 2023

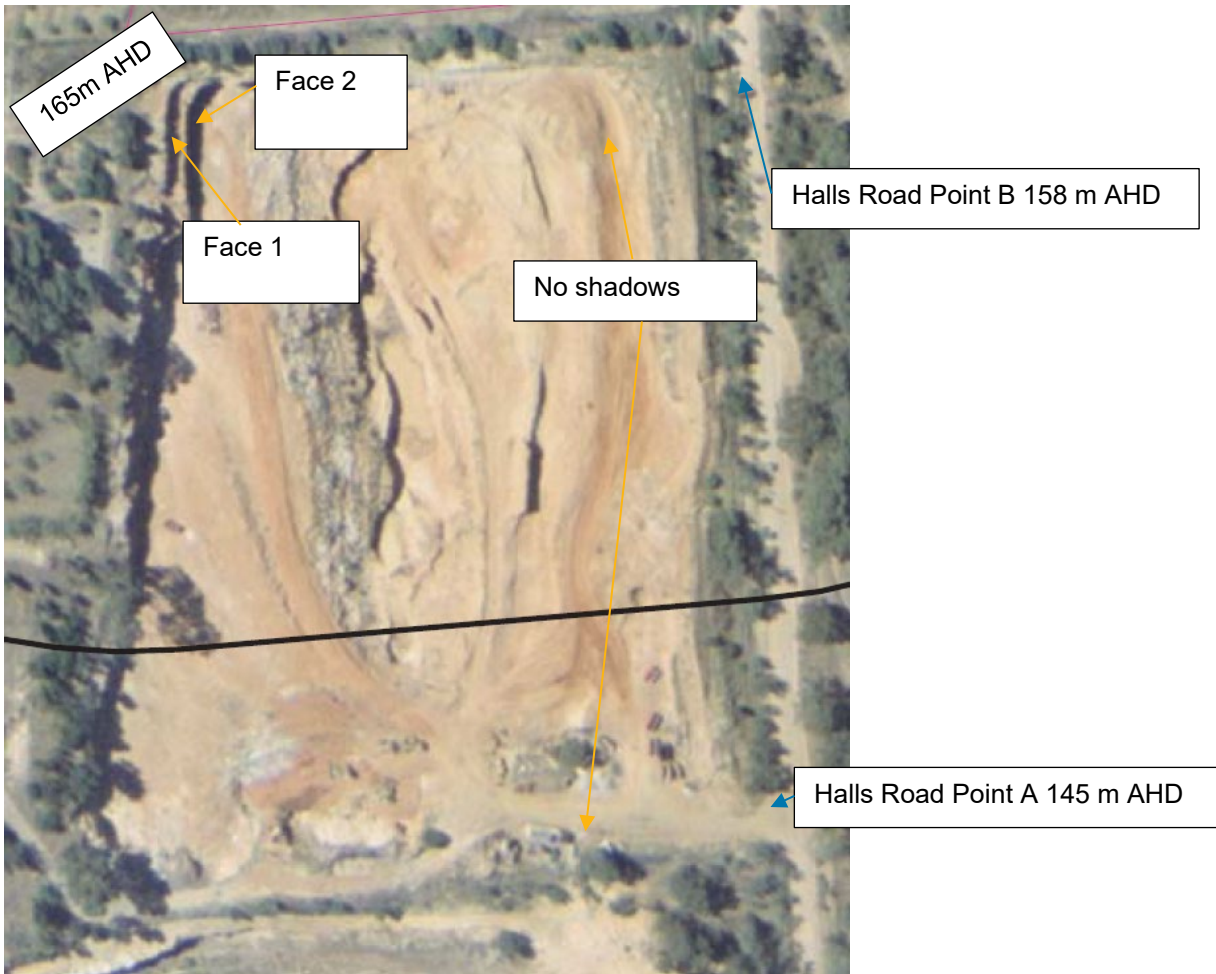
Figure 5-2 1979 image of the VL – see shadow length in northwest corner (see PSI report for original inc. scale bar)

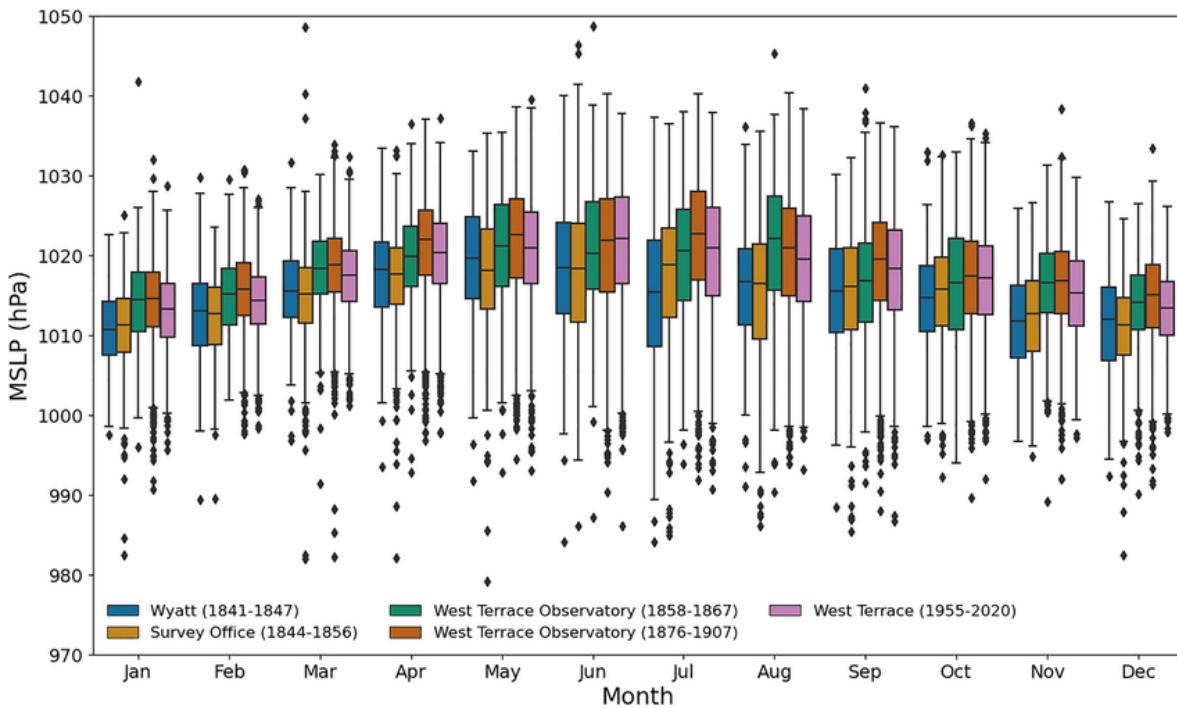
Figure 5-8 Daily mean sea level pressure (MSLP) grouped by month from the Wyatt, Survey Office and West Terrace Observatory datasets for Adelaide. Combined monthly means of MSLP from Bureau of Meteorology stations West Terrace (station number: 023000) and Kent Town (station number: 023090). Values are given in hectopascals (hPa). Outliers are defined as $1.5 \times$ interquartile range⁴

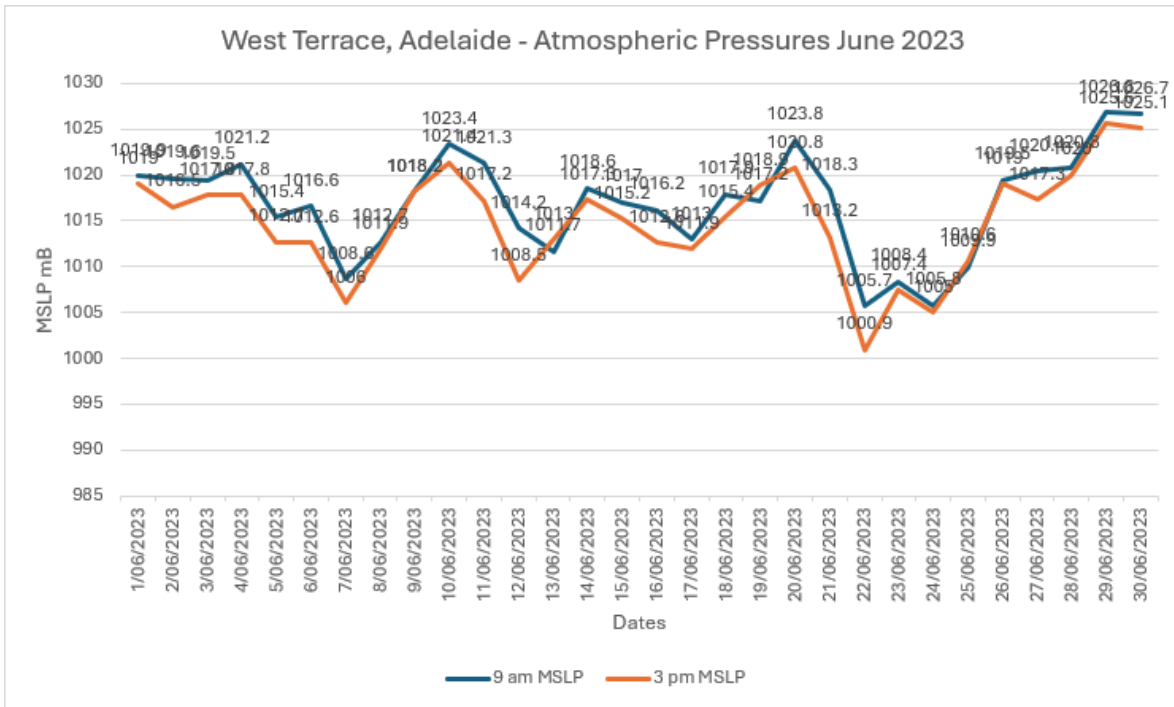
Figure 5-9 MSLP June 2023 Adelaide West Terrace BOM

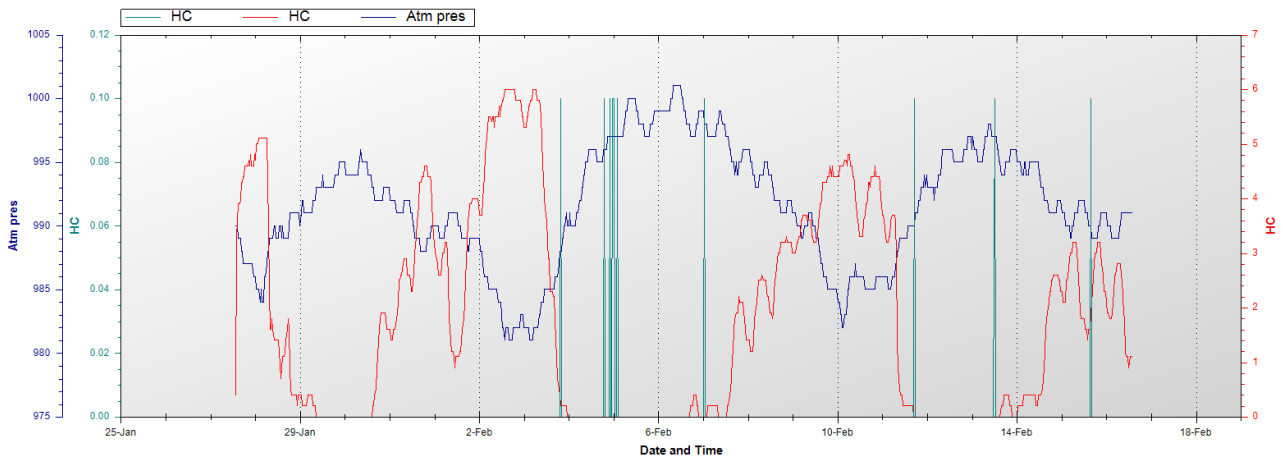
Figure 5-1 MW04 (HC Red = Carbon Dioxide, HC Green = Methane, Atm Blue = Atmospheric Pressure):

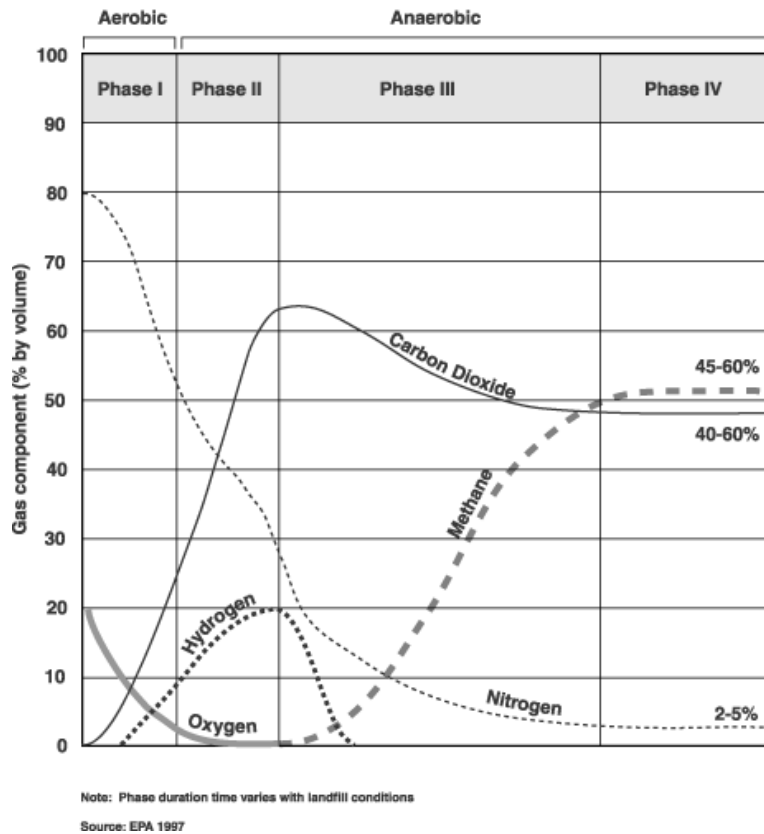
Figure 8-1 Production phases of typical landfill gas (ATSDR 1998)

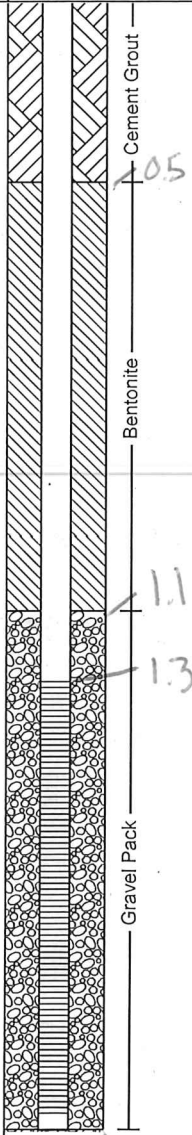
Depth (m)	Well Installation	Graphic Log	Lithology	Samples	Moisture	Consistency	PID	Comments
0.5 1.0 1.5 2.0 2.5 3.0 3.5 4.0 4.5 5.0 5.5

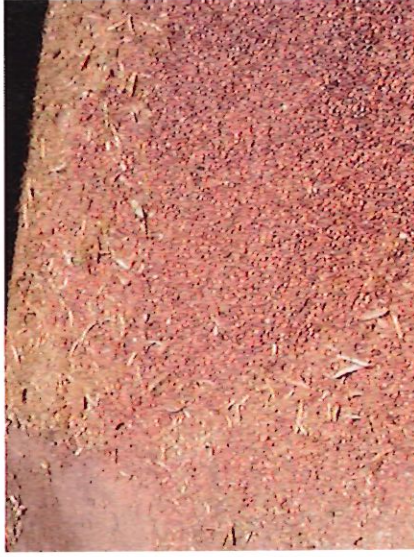
Plate S3: Crushed brick fill typically found on site.
